Monthly Oversight Report 66  
44728 AES [46526 RAC]  
ACS NPL Site  
Griffith, Indiana  
June 3, 2006 – June 30, 2006

Subject: Monthly Oversight Summary Report  
No. 66 for June 2006

**Monthly Oversight Summary Report No. 66**  
**ACS Superfund Site**  
**TO 057, 44728.238 (AES) [WA57, 46526.238 (RAC)]**

**Reporting Period:** Month of June (June 3 through June 30, 2006)

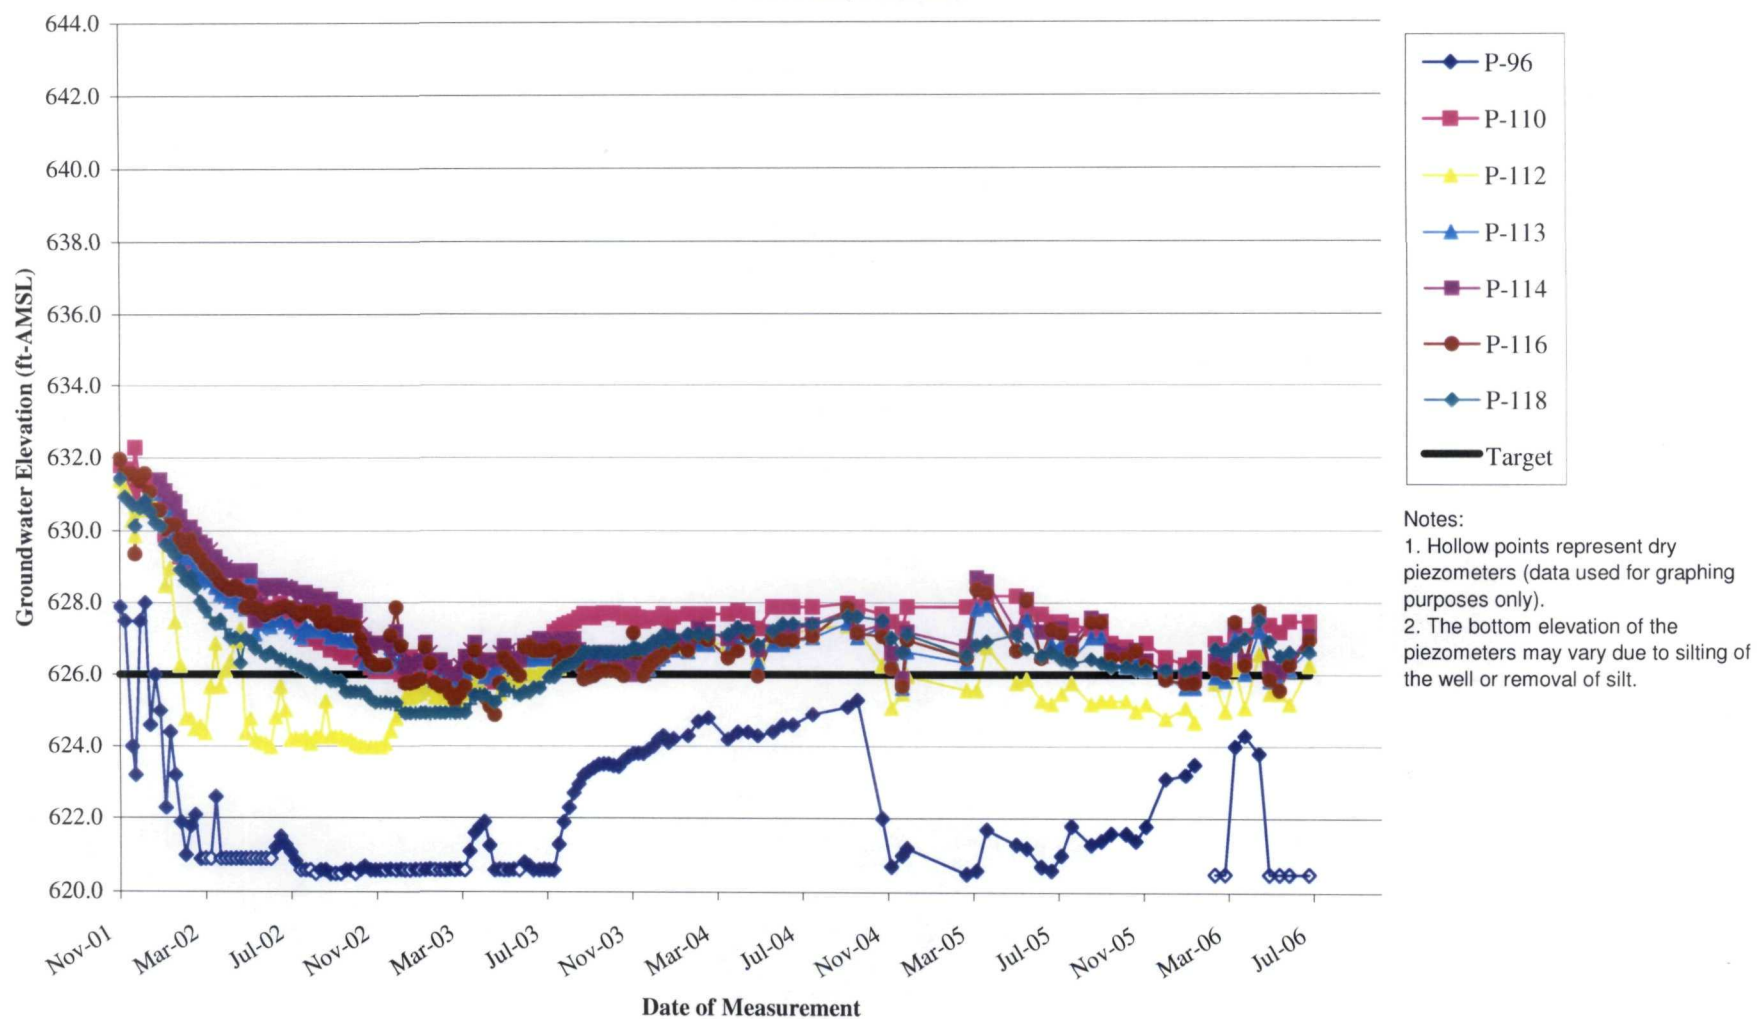
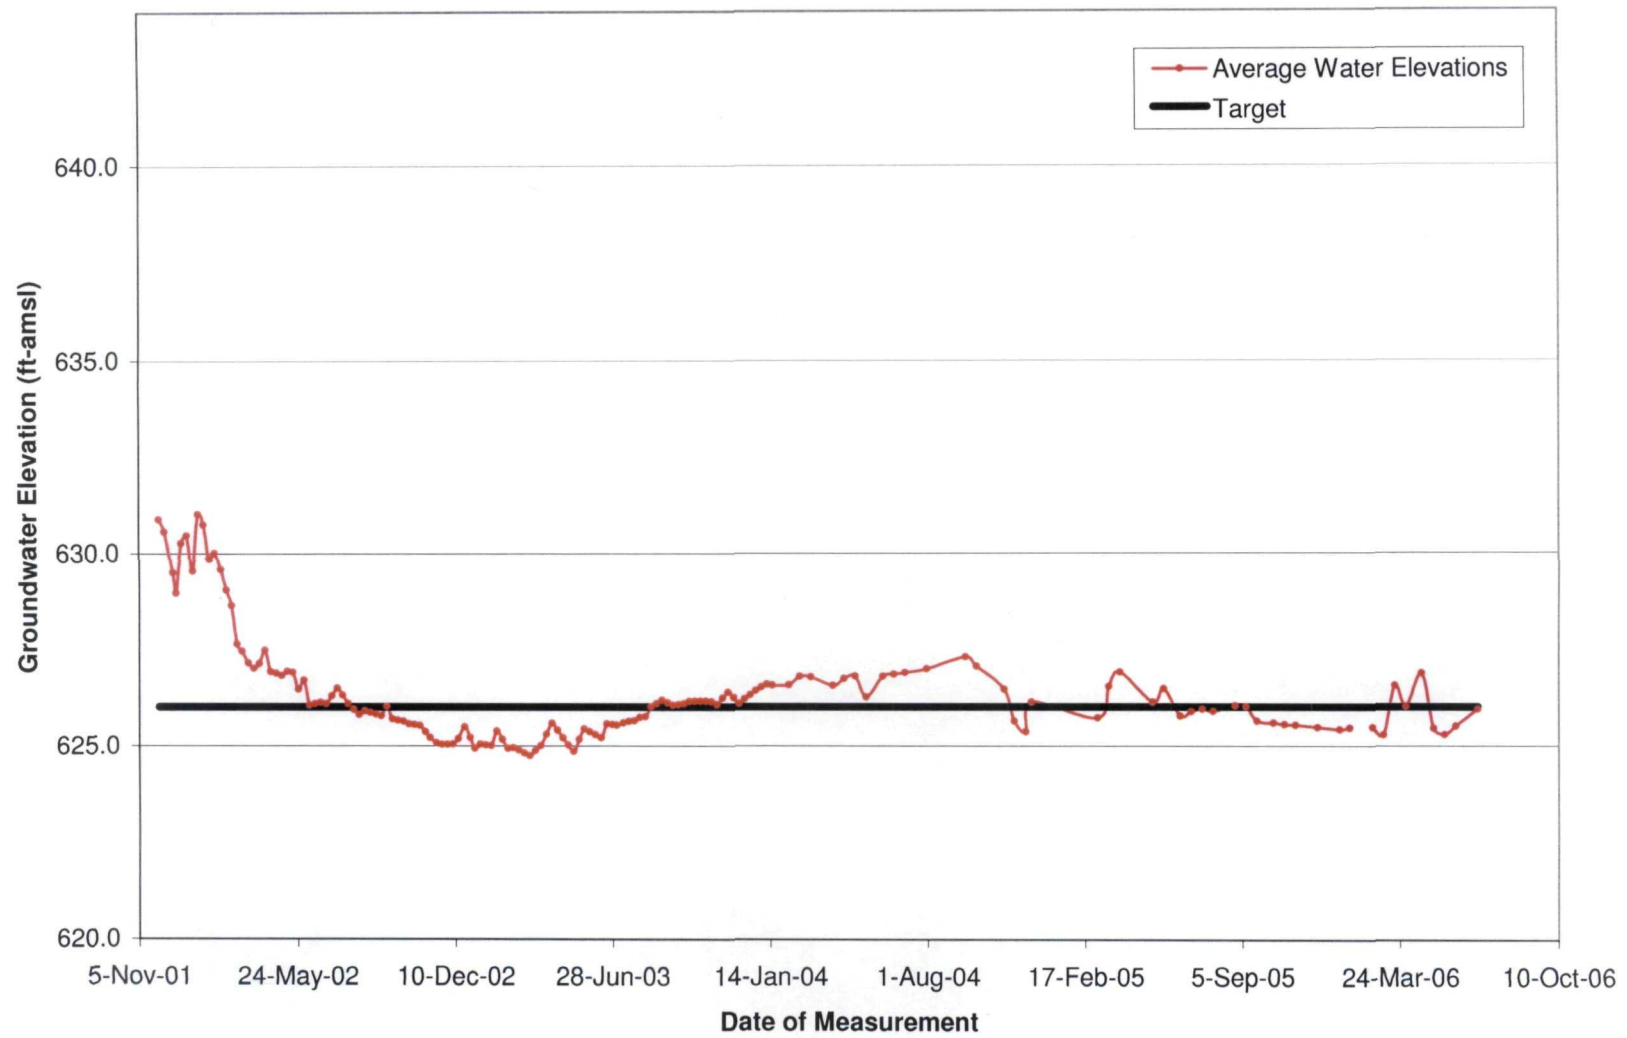
**Figure 3**  
**Off-Site Water Level Status - Piezometers**  
**Groundwater Monitoring**  
**ACS NPL Site**  
**Griffith, Indiana**

### Off-Site Average Elevations

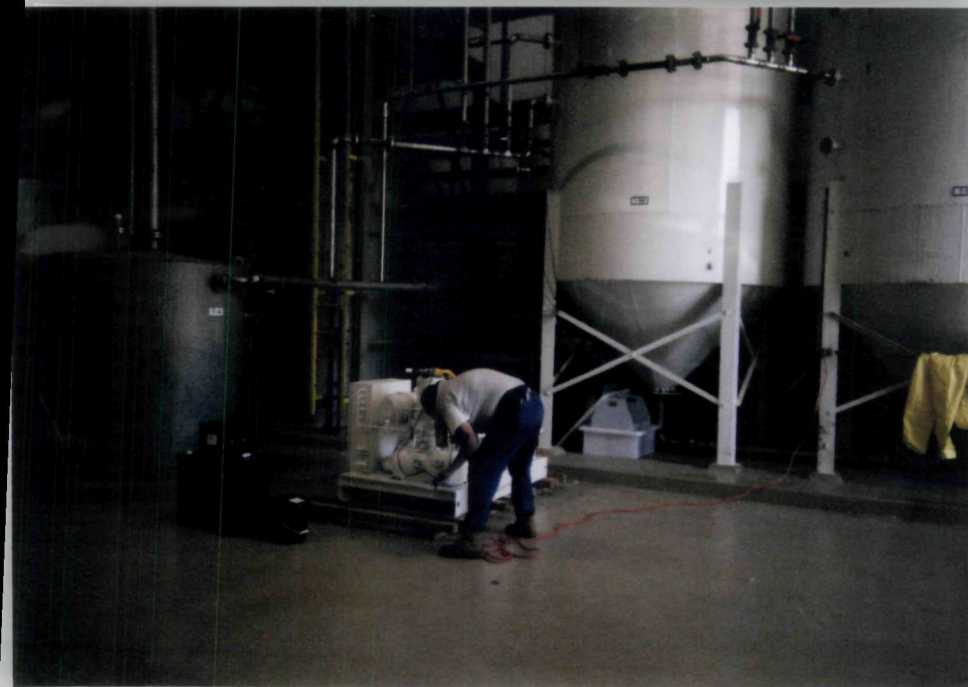
Site: American Chemical Service, Inc.  
Proj. #: 44728 AES [46526 RAC]  
Roll: 88 Photo #1  
Date: 6-19-06 Time: 0915  
Photographer: Chad Gailey  
Description: Photo facing west inside the treatment plant showing Terry Frigtz of Ryan preparing the new compressor for installation.

9:15 Photo 1 Role 88, Facing West  
INSIDE The GWTP of Terry Fritze  
Preparing the New Compressor for  
Installation.

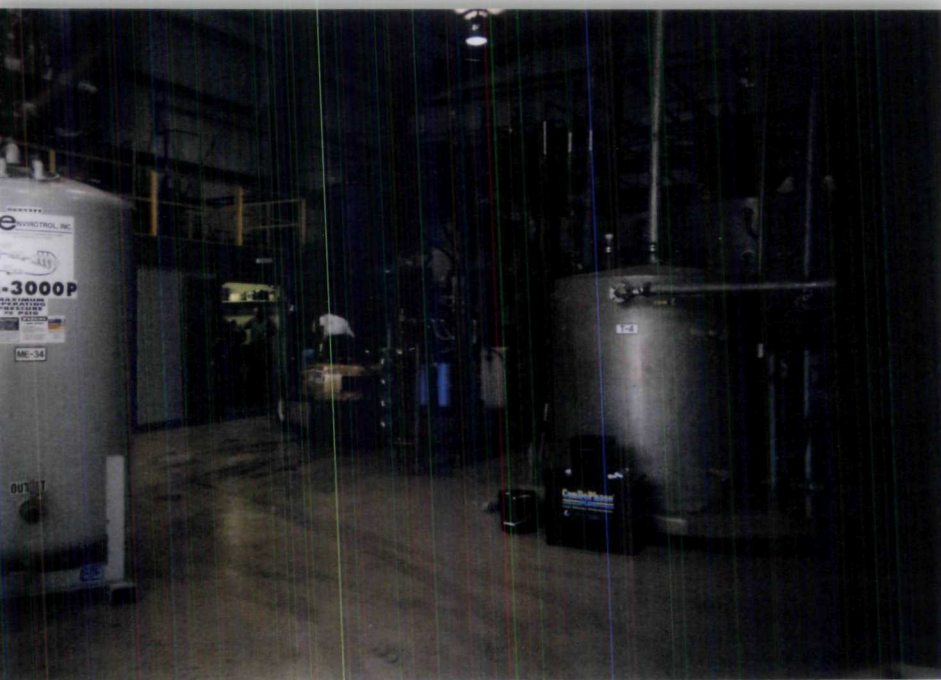
Site: American Chemical Service, Inc.  
 Proj. #: 44728 AES [46526 RAC]  
 Roll: 88 Photo #3  
 Date: 6-19-06 Time: 1035  
 Photographer: Chad Gailey  
 Description: Photo facing southeast inside GWTP  
 showing Lee Orosz preparing to remove old  
 compressor.

10:35 Picture 3 Pole 88 Facing SE  
INSIDE GWTP of Lee CROSS  
Setting up to remove old Compressor.

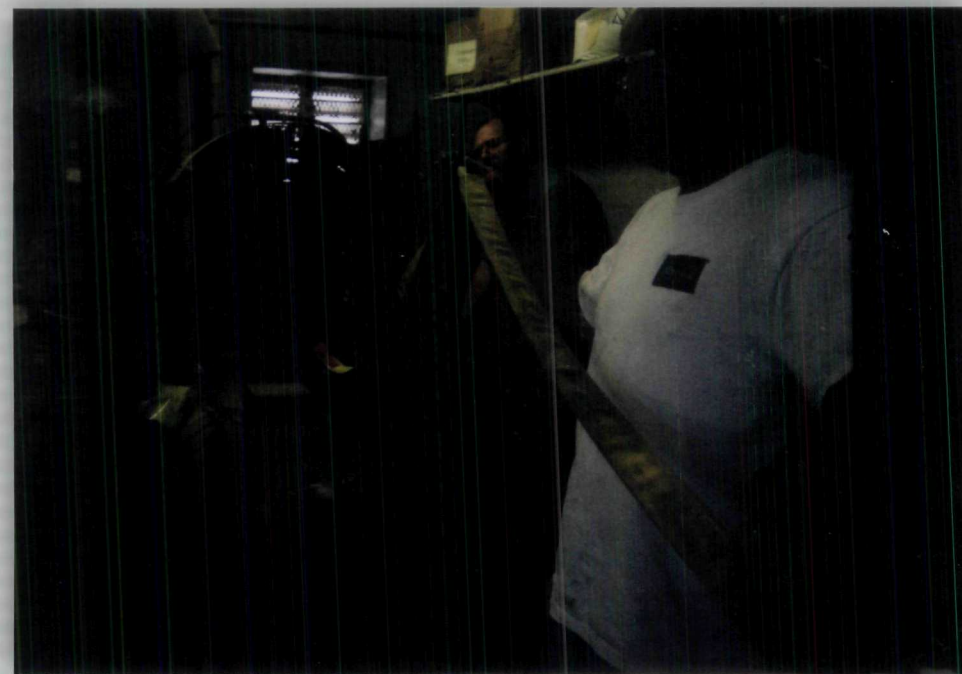
Site: American Chemical Service, Inc.  
 Proj. #: 44728 AES [46526 RAC]  
 Roll: 88 Photo #4  
 Date: 6-19-06 Time: 1112  
 Photographer: Chad Gailey  
 Description: Photo looking east into compressor room  
 as MWH prepares to connect the old compressor tank  
 for removal.

11:12 Picture 4 Pole 88 Facing East  
INSIDE GWTP of MWH hook up  
the Second Compressor Pump. for  
Removal.

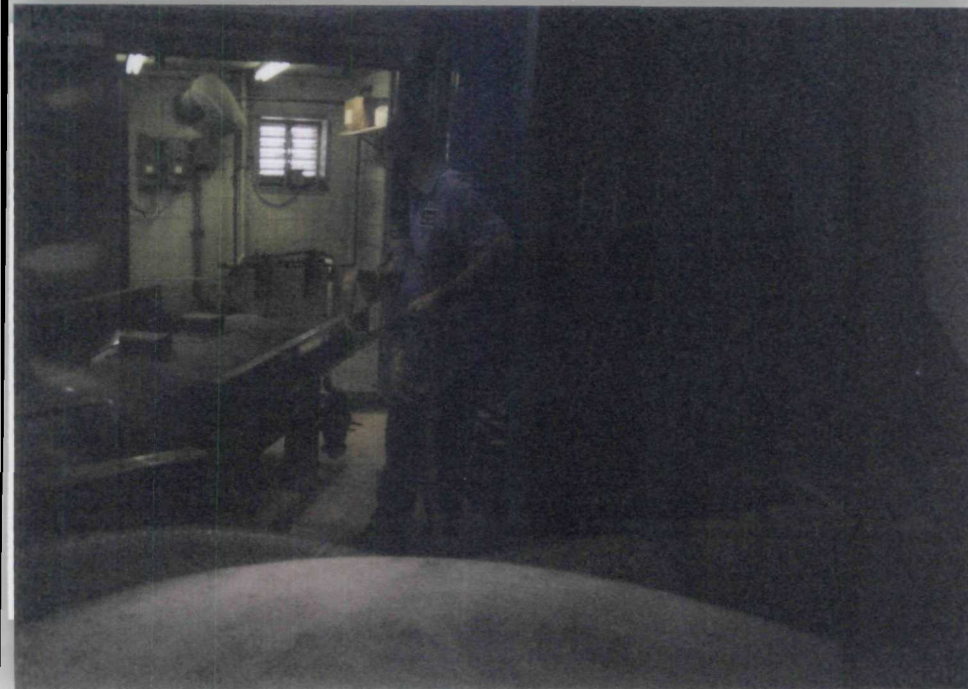
Site: American Chemical Service, Inc.  
Proj. #: 44728 AES [46526 RAC]  
Roll: 88 Photo #5  
Date: 6-19-06 Time: 1130  
Photographer: Chad Gailey  
Description: Photo facing east showing MWH removing the air compressor tank from the compressor room.

11:30 Picture 5 Pole 88 Facing East  
INSIDE GWTP of MWH Removing  
the Air Compressor Tank.

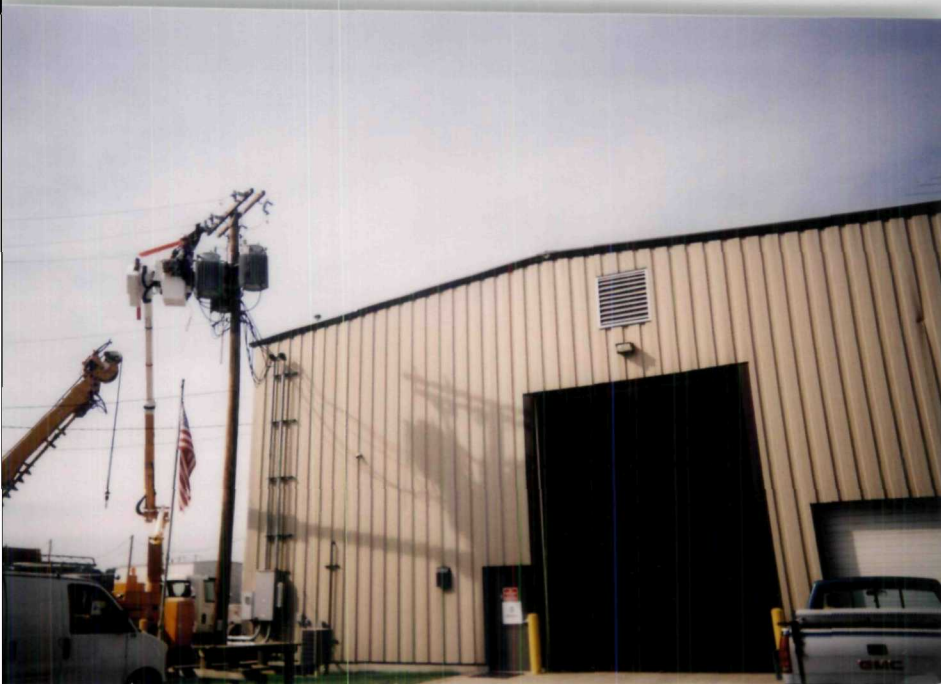
Site: American Chemical Service, Inc.  
 Proj. #: 44728 AES [46526 RAC]  
 Roll: 88 Photo #7  
 Date: 6-20-06 Time: 0903  
 Photographer: Chad Gailey  
 Description: Photo facing southeast showing NIPSCO  
 removing leaking electrical transformer.

- Observed on June 20, Ryan complete installation of electrical, mechanical, and piping elements for the new air compressor.
- Observed on June 20, Northern Indiana Public Service Company (NIPSCO) disconnect electrical power to the GWTP, and remove, repair and reinstall a leaking electrical transformer on the pole near the GWTP building. MWH reported that electrical power was restored later in the afternoon of June 20.

9:03 Picture 7 Pole 88 Facing SE  
@ GWTP of NIPSCO working  
on the Transformer.
